INDOOR AIR QUALITY REASSESSMENT

**Gordon Mitchell Middle School
435 Central Street
East Bridgewater, Massachusetts**

Prepared by:
Massachusetts Department of Public Health
Bureau of Environmental Health Assessment
July, 2000

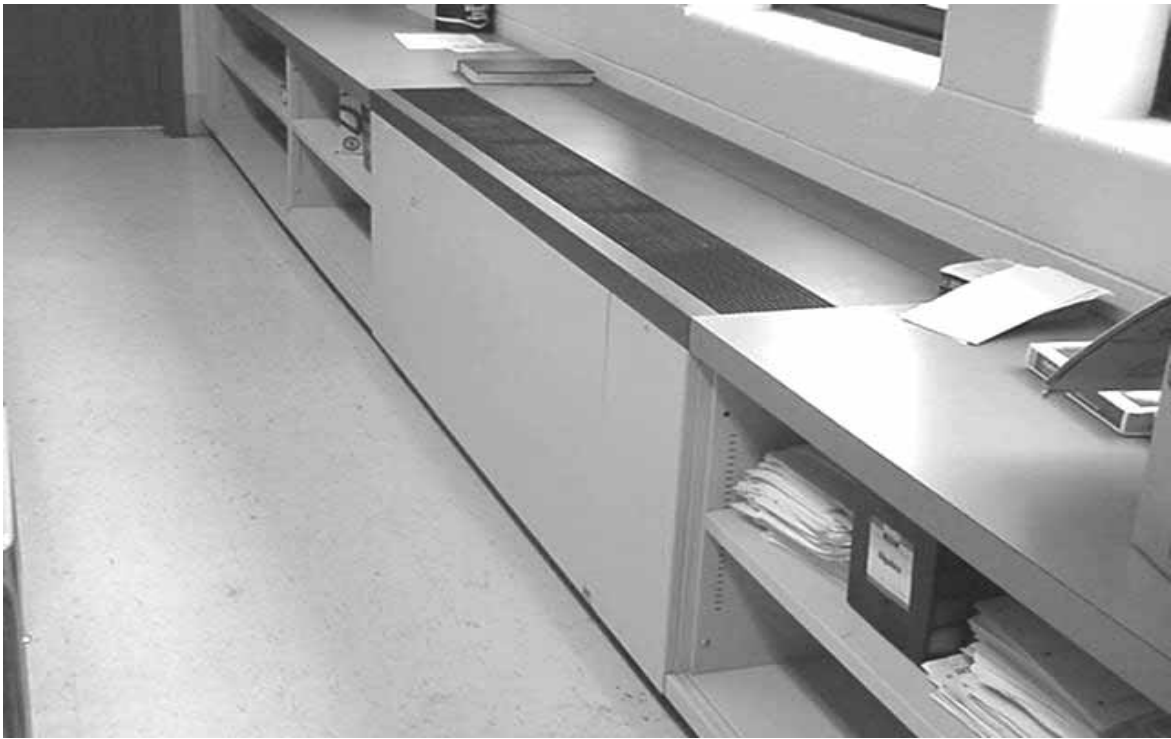
Picture 1

It can be seen from the tables that carbon dioxide levels were elevated above 800 parts per million parts of air (ppm) in thirty-seven of forty-six areas surveyed, which is indicative of an overall ventilation problem in this school. Fresh air in classrooms is supplied by a unit ventilator (univent) system (see Pictures 1 & 2). Univents draw air from outdoors through a fresh air intake located on the exterior walls of the building (see Picture 3) and return air through an air intake located at the base of each unit (see [Figure 1](#)). Fresh air and return air are mixed, filtered, heated and provided to classrooms through a fresh air diffuser located in the top of the unit. Univents were deactivated in a number of classrooms surveyed. BEHA staff were able to activate several of these units using univent power switches (see Tables).

Classroom Unit Noted in 1997 Addition

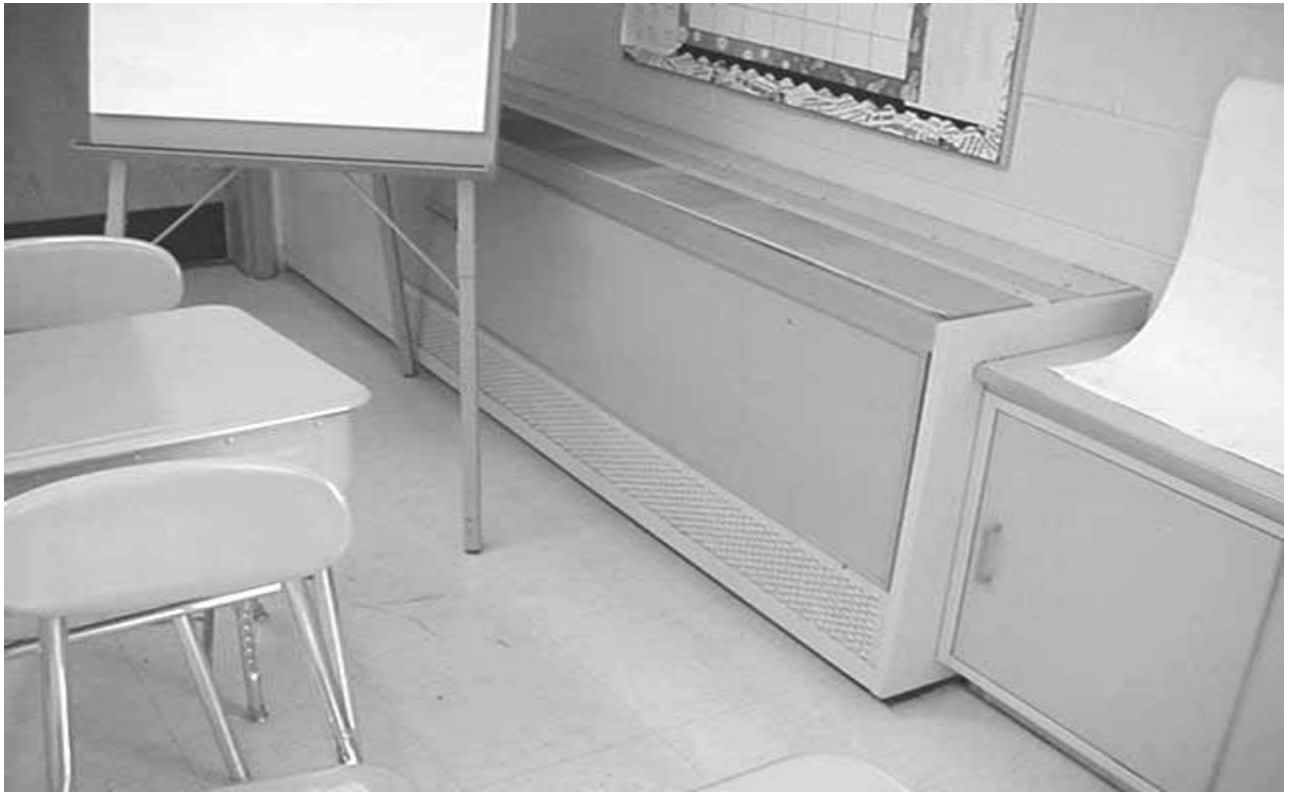
Picture 2

Classroom Univent in 1968 Wing Please Note These Units Appear to be Original Equipment

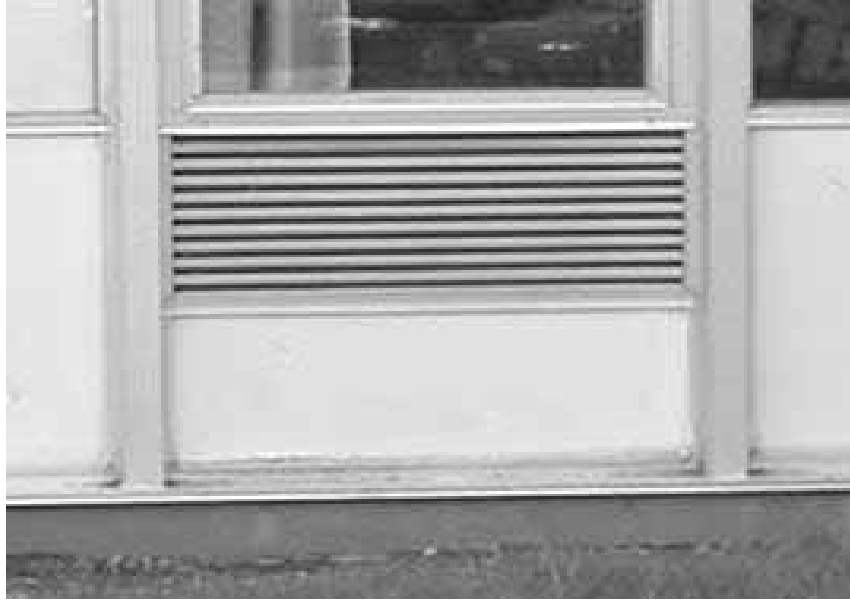
Picture 3

Exterior Wall-Mounted Univent Fresh Air Intake

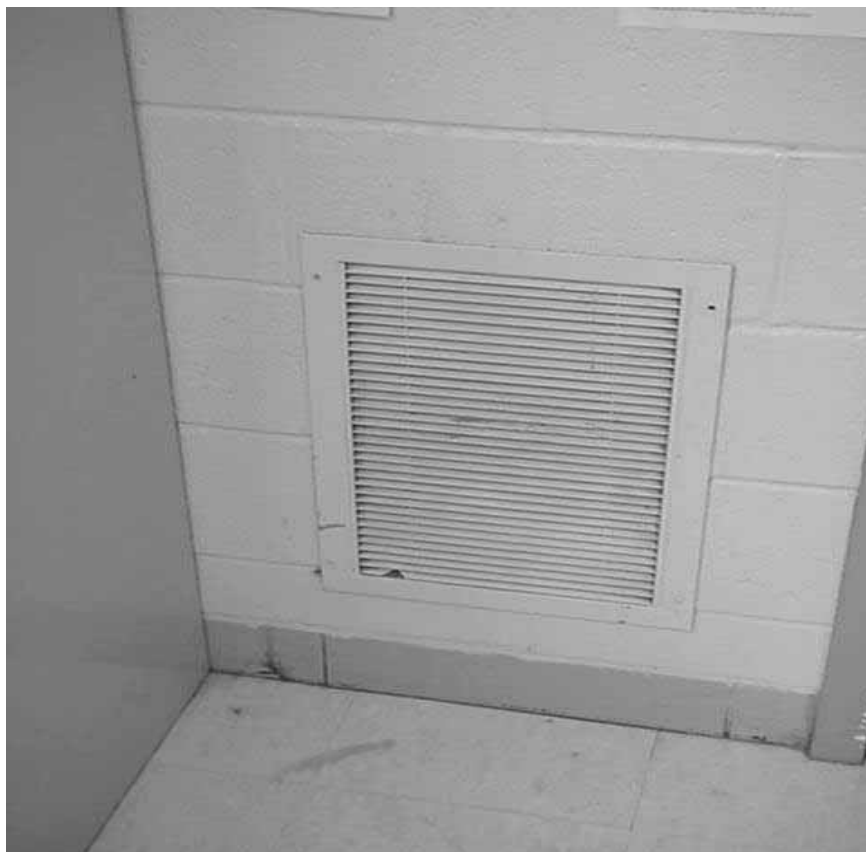
Picture 4

The mechanical exhaust ventilation system in the 1968 wing consists of wall-mounted exhaust vents (see Picture 4). As with the univents, a number of exhaust vents were obstructed by tables, chairs, boxes and other items (see Picture 5). In addition, many of these vents are located on walls behind cabinets. This design obstructs airflow into the exhaust vents and degrades the efficiency of the system to remove environmental pollutants that commonly build-up indoors. Slotted spaces were cut into the baseboard of cabinets in front of these vents in an attempt to facilitate airflow (see Picture 6).

Wall-Mounted Classroom Exhaust Vent Noted in 1968 Wing

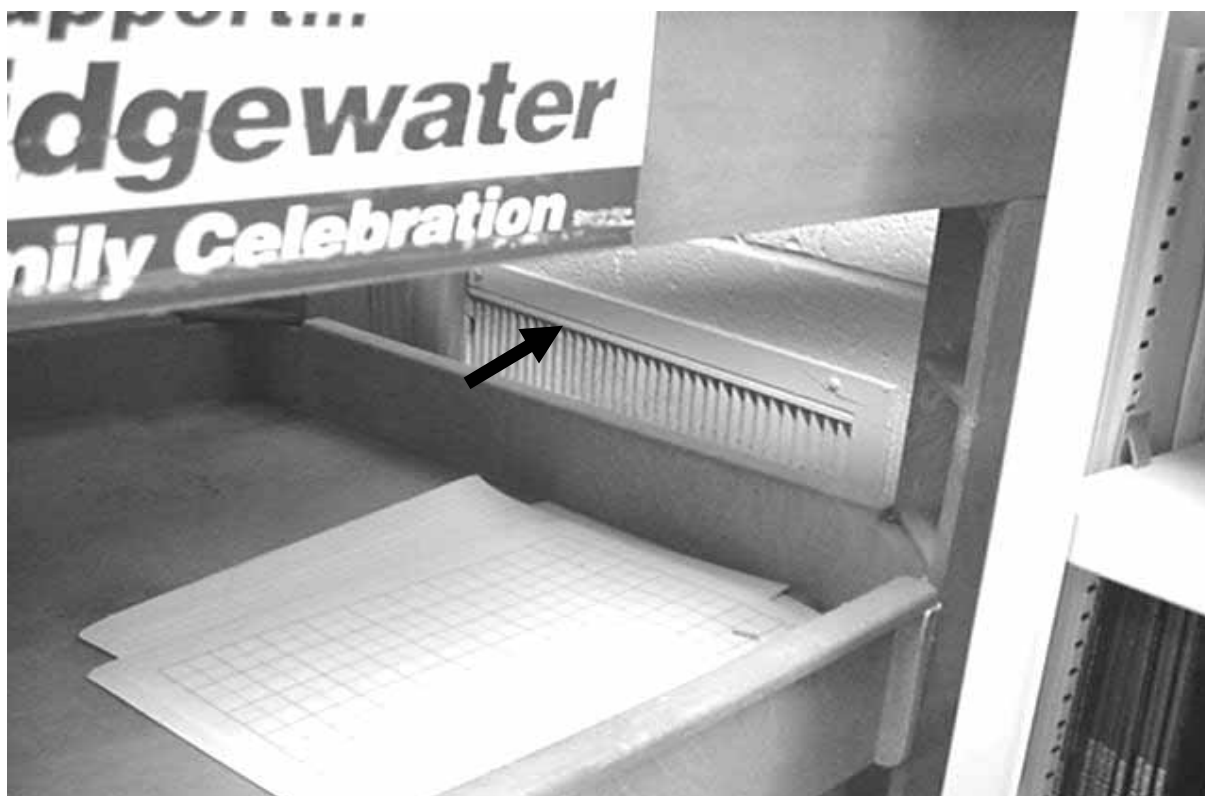
Picture 5

Exhaust Vent Obstructed by Cart

1. To maximize air exchange, the BEHA recommends that both supply and exhaust ventilation operate continuously during periods of school occupancy independent of classroom thermostat control.
2. Examine each univent for function. Survey classrooms for univent function to ascertain if an adequate air supply exists for each room. Consider consulting a heating, ventilation and air conditioning (HVAC) engineer concerning the calibration of univent fresh air control dampers school-wide.
3. Inspect exhaust motors and belts for proper function, repair and replace as necessary. Consider consulting a heating, ventilation and air conditioning (HVAC) engineer concerning the proper function of exhaust ventilation in the 1997 addition.
4. Remove all blockages from univents and exhaust vents. Examine the feasibility of reconfiguring exhaust vents obstructed by cabinets.

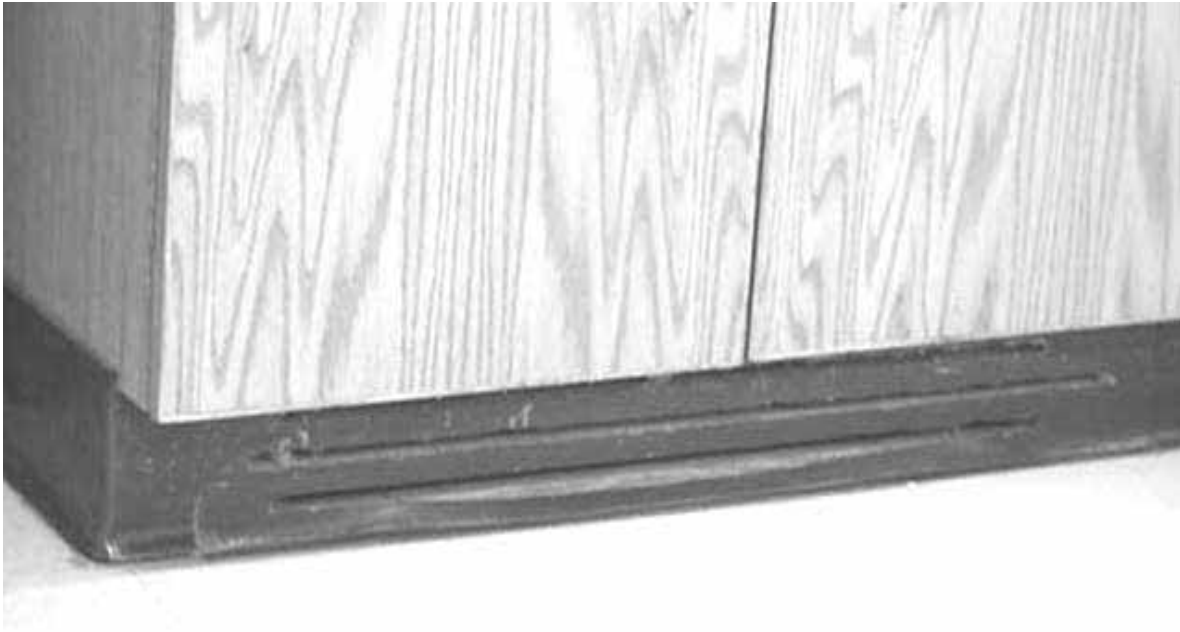
Picture 6

**Slotted Holes in Cabinet Baseboard to Provide Exhaust Ventilation
Note Exhaust Vent is Located on Wall Behind Cabinet**

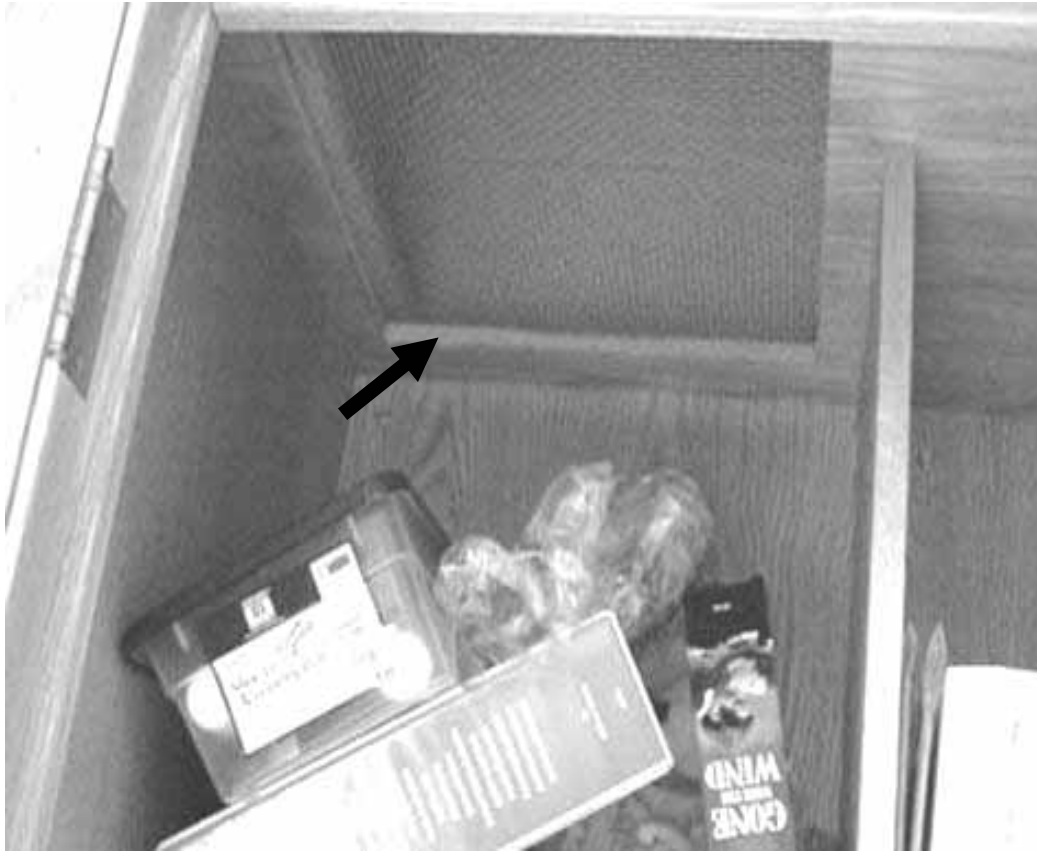
Picture 7

Exhaust ventilation in the 1997 addition classrooms is provided by vents located in the upper portions of storage closets (see Picture 7). Classroom air is drawn into the coat closet via a passive vent mounted on the lower portion of the closet door (see Picture 8). This design allows for the vents to be easily blocked by stored materials. None of these vents were noted to be drawing air during the assessment. Each exhaust vent is equipped with dampers/flues (see Picture 9), which were closed in numerous cases. Closed dampers inhibit airflow of stale air from the classroom into the exhaust system. In order to function properly, these vents must be clear and remain free of obstructions. BEHA staff recommended to school officials that they contact the architect and/or their HVAC consultant regarding the proper function of this system.

Coat Closet Exhaust Vent Noted in 1997 Addition Classrooms

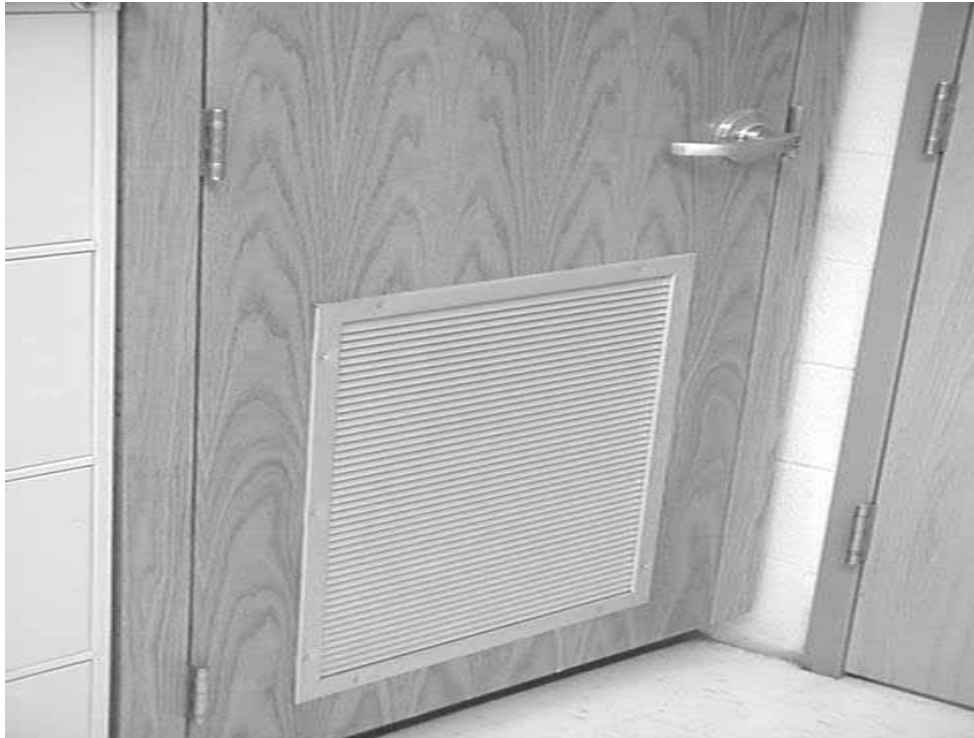
Picture 8

Passive Door Vent Located on Coat Closet Door

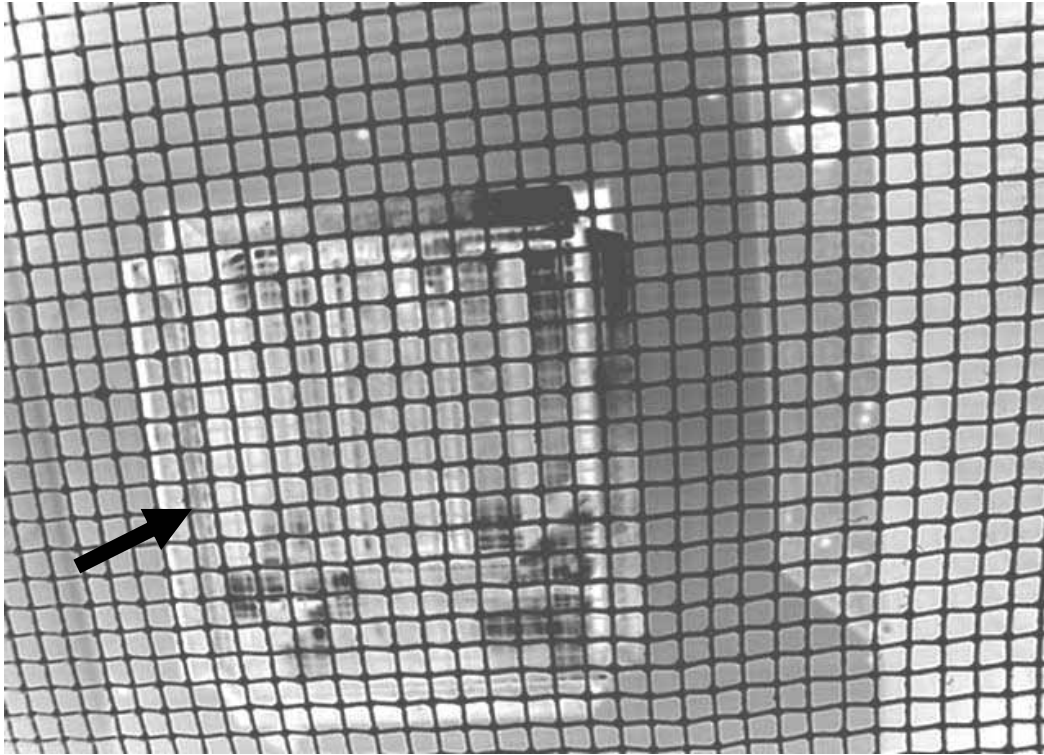
Picture 9

Damper Noted Shut in Coat Closet Exhaust Ventilation Ductwork in 1997 Addition

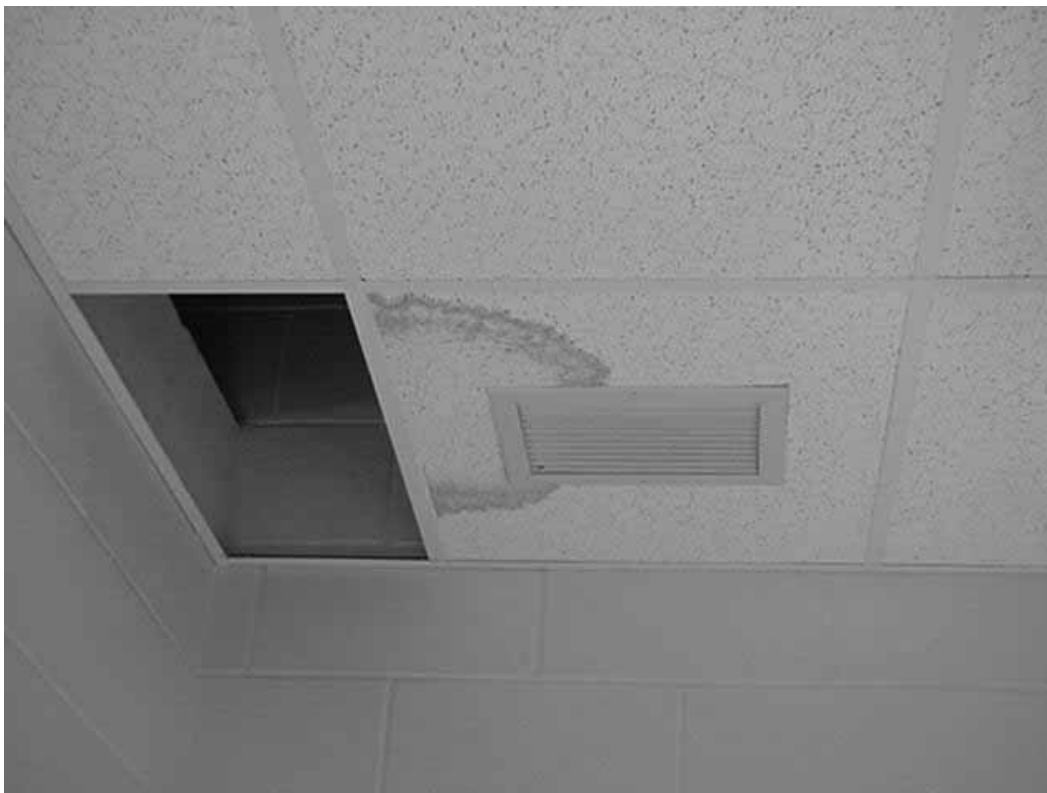
Picture 10

Several areas had water stained ceiling tiles (see Tables/Picture 10). Water-damaged ceiling tiles can provide a source of mold and mildew and should be replaced after a water leak is discovered and repaired. Mold can be an eye and respiratory irritant to certain sensitive individuals. The boy's restroom on the first floor contained a water-stained ceiling tile with possible mold growth.

irritant. Several areas also had open utility holes and/or dislodged ceiling tiles (see Picture 10/Tables). Open utility holes can provide a means of egress for odors, fumes, dusts and vapors between rooms and floors. The movement of ceiling tiles can introduce dirt, dust and particulate matter into occupied areas of the school. These materials can be irritating for certain individuals.

Missing and Water-Stained Ceiling Tiles Noted in 1997 Addition

8. Repair roof/plumbing leaks. Replace any remaining water-stained ceiling tiles and pipe insulation. Examine the area above and around these areas for mold growth. Disinfect areas of water leaks with an appropriate antimicrobial.

10. Replace missing ceiling tiles and fill utility holes to prevent the egress of dirt, dust and particulate matter between rooms and floors.
11. Install weather-stripping on woodshop door to prevent woodshop odors/dusts from penetrating into adjacent areas of the school. Do not conduct wood shop activities with the hallway door open during hours of school occupancy.

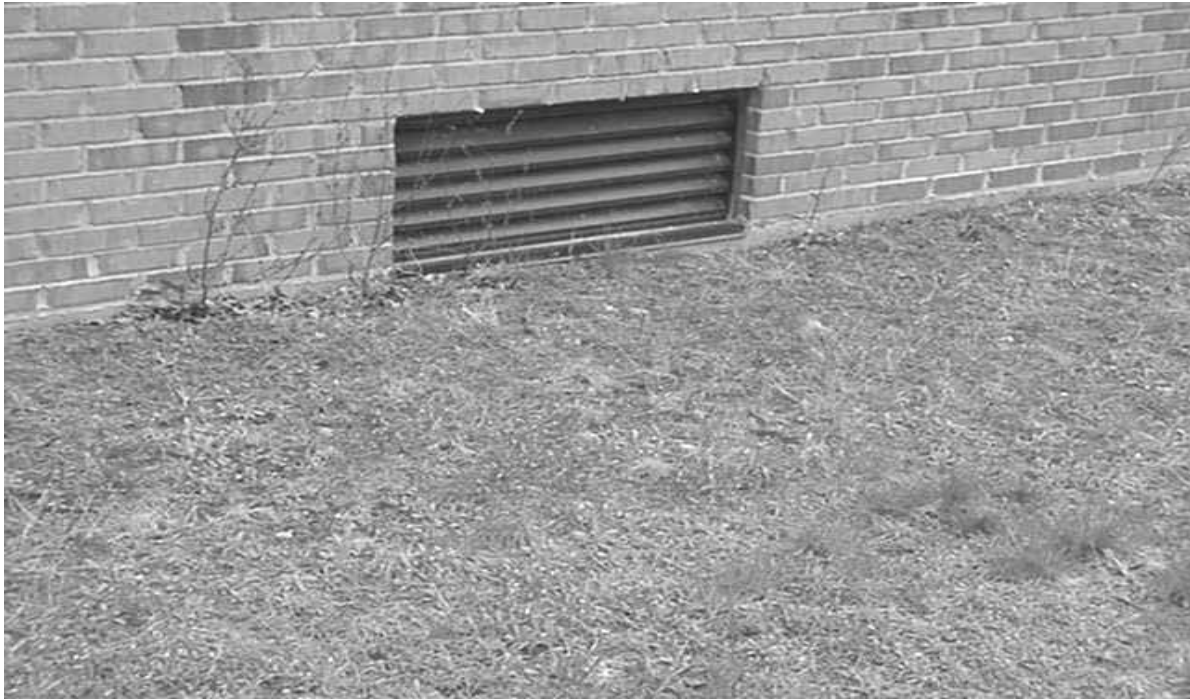
Picture 11

Along the perimeter of the building (and interior courtyard), univent fresh air intakes were noted close to ground level (see Picture 11). Care should be taken to ensure that fresh air intakes remain clear of obstructions (e.g., snow, shrubbery, etc.) to avoid the entrainment of dirt, moisture, pollen and/or other particulate matter.

Univent Fresh Air Intake Vent on Exterior of 1997 Addition

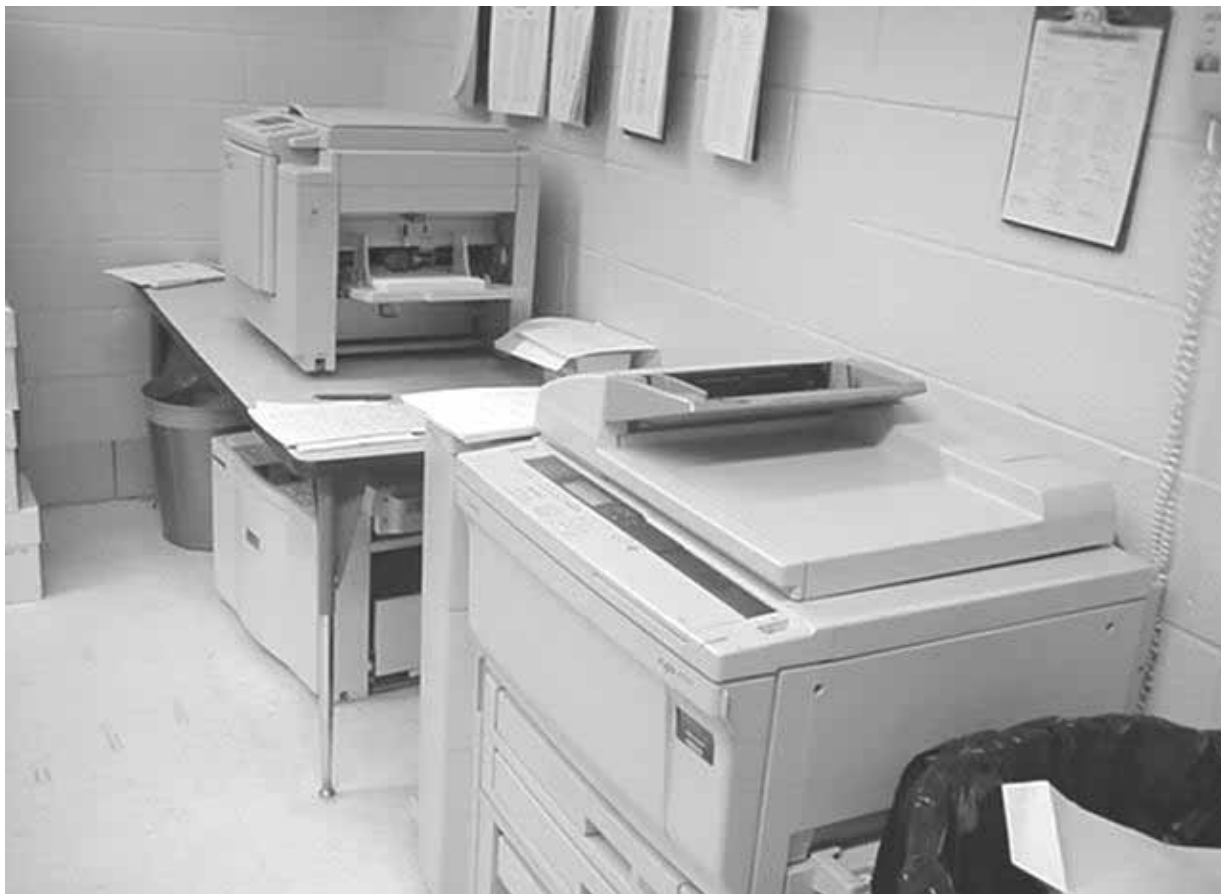
Picture 12

The teacher's workroom contains a lamination machine and photocopiers (see Picture 12). Lamination machines give off odors. Volatile organic compounds (VOCs) and ozone can be produced by photocopiers, particularly if the equipment is older and in frequent use. Ozone is a respiratory irritant (Schmidt Etkin, D., 1992). School personnel should ensure that local exhaust ventilation is activated while equipment is in use to help reduce excess heat and odors in these areas.

Photocopiers Noted in First Floor Teacher's Workroom

13. Relocate dry erase board in classroom 107 away from the univent fresh air diffuser.
14. Change or clean filters for univents and air handling units (AHUs) as per the manufacture's instructions or more frequently as needed to prevent the re-aerosolization of dirt, dust and particulate matter.
15. Repair/restore exhaust ventilation for restrooms to remove moisture and to prevent restroom odors from penetrating into adjacent areas.
16. Examine the feasibility of providing local exhaust ventilation for gas stoves in the consumer science area.
17. Ensure exhaust ventilation is functioning in areas that contain lamination machines and photocopiers.
